THAMES RIVER BASIN
NORWICH, CONNECTICUT

GREENVILLE DAM
CT. 00206

PHASE 1 INSPECTION REPORT
NATIONAL DAM INSPECTION PROGRAM

OCTOBER, 1980

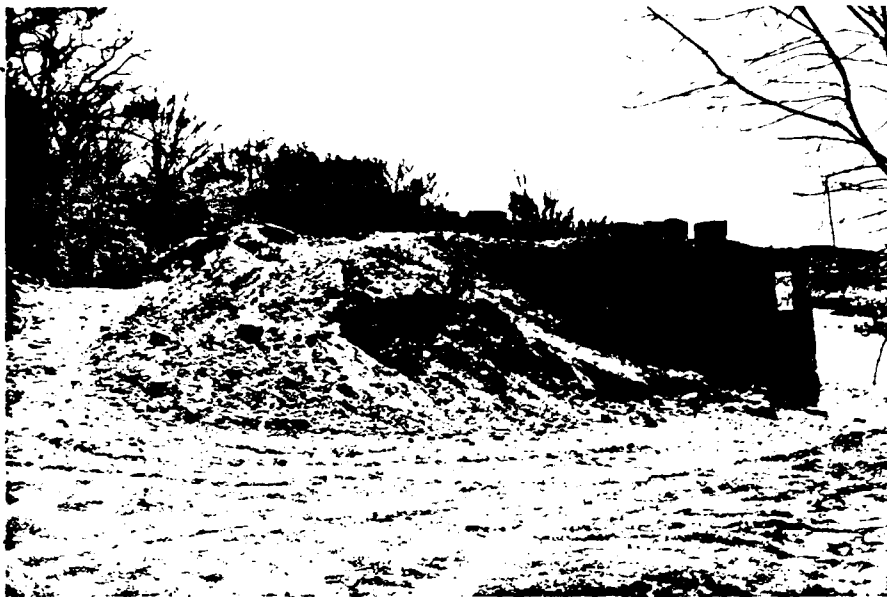
PHOTO C-1 Upstream face of dam , left embankment.

2. Left Embankment. The left masonry block wall of the dam is shown in Photos C-1 and C-5. A concrete training wall has been built downstream from the masonry wall to divert water away from the toe of the downstream masonry wall and adjacent earth embankment (Photos C-5 and C-7). A roadway has been excavated adjacent to the left abutment as indicated in Photos C-1 and C-4. This roadway construction has created a minor depression in the crest profile of the dam. The length and depth of this depression could not be measured and inspected due to overflow conditions. A small seep was noted near the downstream toe of the embankment approximately 30 ft. to the left of the end of the masonry training wall. This seepage zone can be observed in Photo C-13. The Owner reports that repair work is presently taking place at the toe of the left embankment where a small tributary flows into the

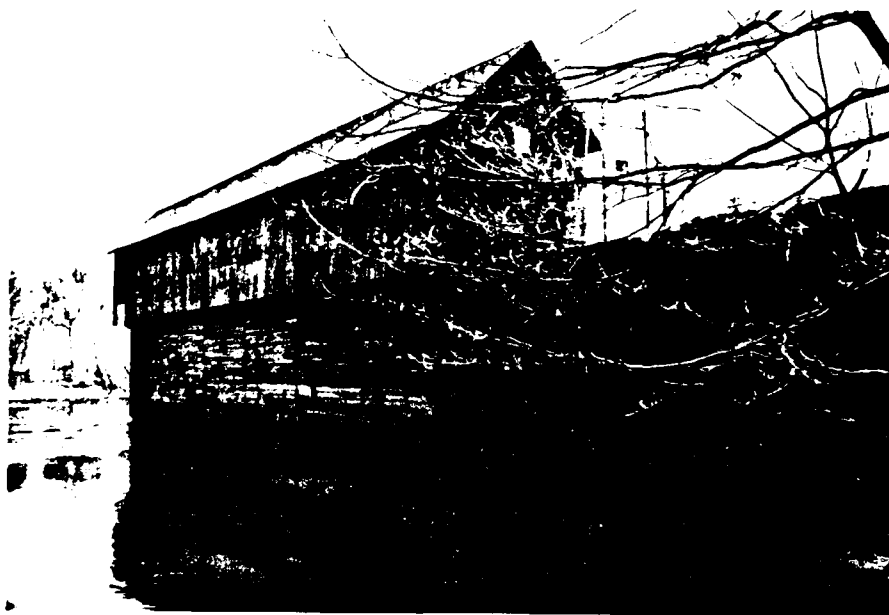
PHOTO C-2 Upstream face of dam, right embankment.

2. Gatehouse and Gate Controls. The gatehouse is a timber superstructure on the stone masonry portion of the embankment. This structure is shown in Photos C-2, C-10, and C-12. The general condition of the superstructure was to be judged fair. The gates appeared to be well maintained and in operating condition although an operational check was not conducted. Three of the six gates can be electrically operated, the remaining gates are manually operated.

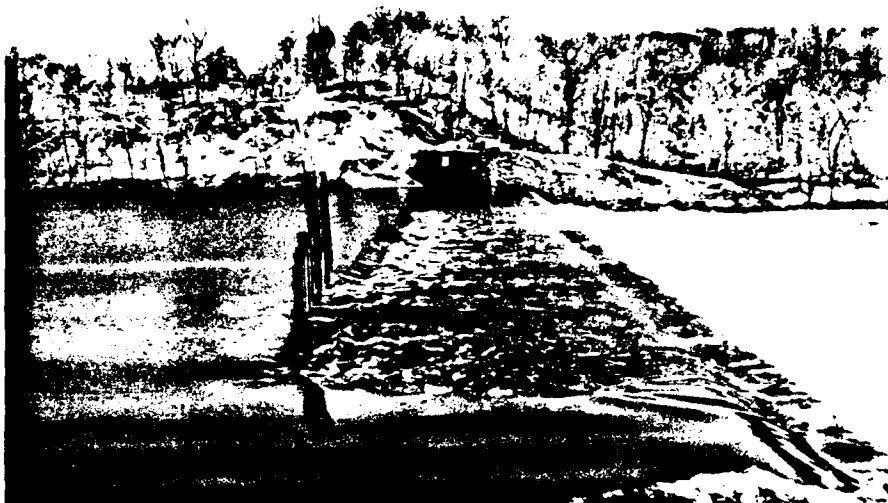
PHOTO C-3 Crest of spillway from right dam embankment.

- a. General. Trees and brush growing on the embankments are generally trimmed side cut on an annual basis. Maintenance was in progress on a portion of the spillway as can be seen in the Photo C-3. Except for some vegetation growing from the masonry of the embankment the facilities appeared to be well maintained.
- b. Operating Facilities. All of the gates receive as needed maintenance to keep them operable. At the time of the inspection, 3 of the gates had recently been overhauled. One gate had been replaced in its entirety, two others, partially replaced.

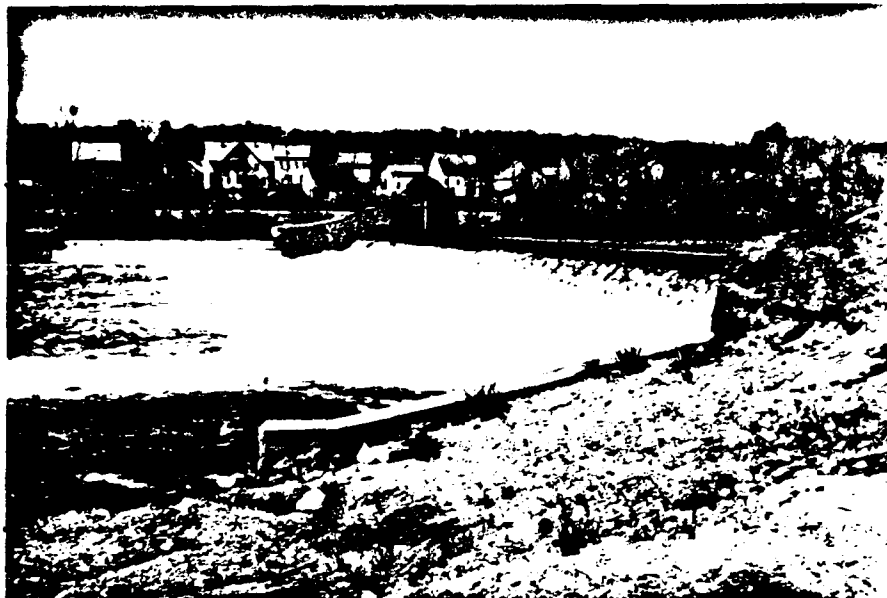
PHOTO C-7 Spillway from left side.

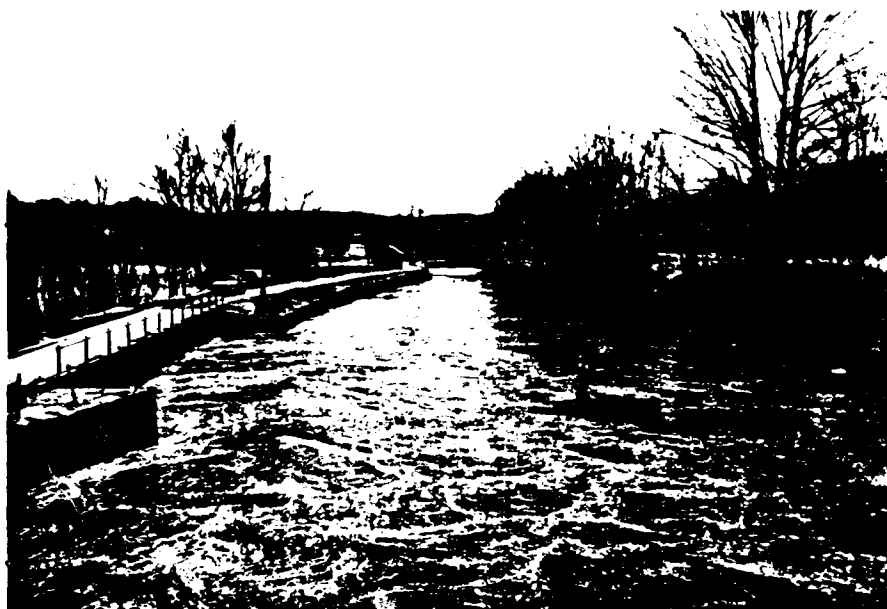
PHOTO C-11 Outlet channel.
